## Building damage survey of the 2016 Kumamoto earthquake

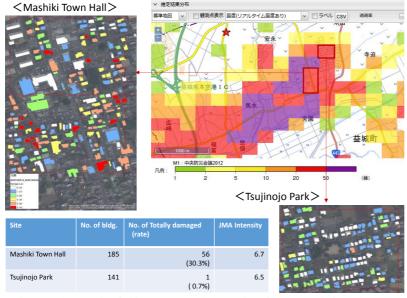
Fig. 2. The result of this survey and the estimation by real-time damage estimation system in Mashiki town.

- Around Mashiki town hall, there are totally damaged buildings in spite of those building code are after 1981. On the other hand, Around Tsujinojo park, there is no major damage.
- In Mashiki town, the result of the system can estimate the distribution of the earthquake building damage. But in Kumamoto city, the result of the system is over-estimated.
