**The 2nd Annual Meeting of the Strategic
Chinese-Korean-Japanese Cooperative Program
Jeju island, Korea, 2012/10/29-31**

Site Amplification Study **— Case of Taipei Basin —**

Kuo-Liang Wen
NCU, Taiwan

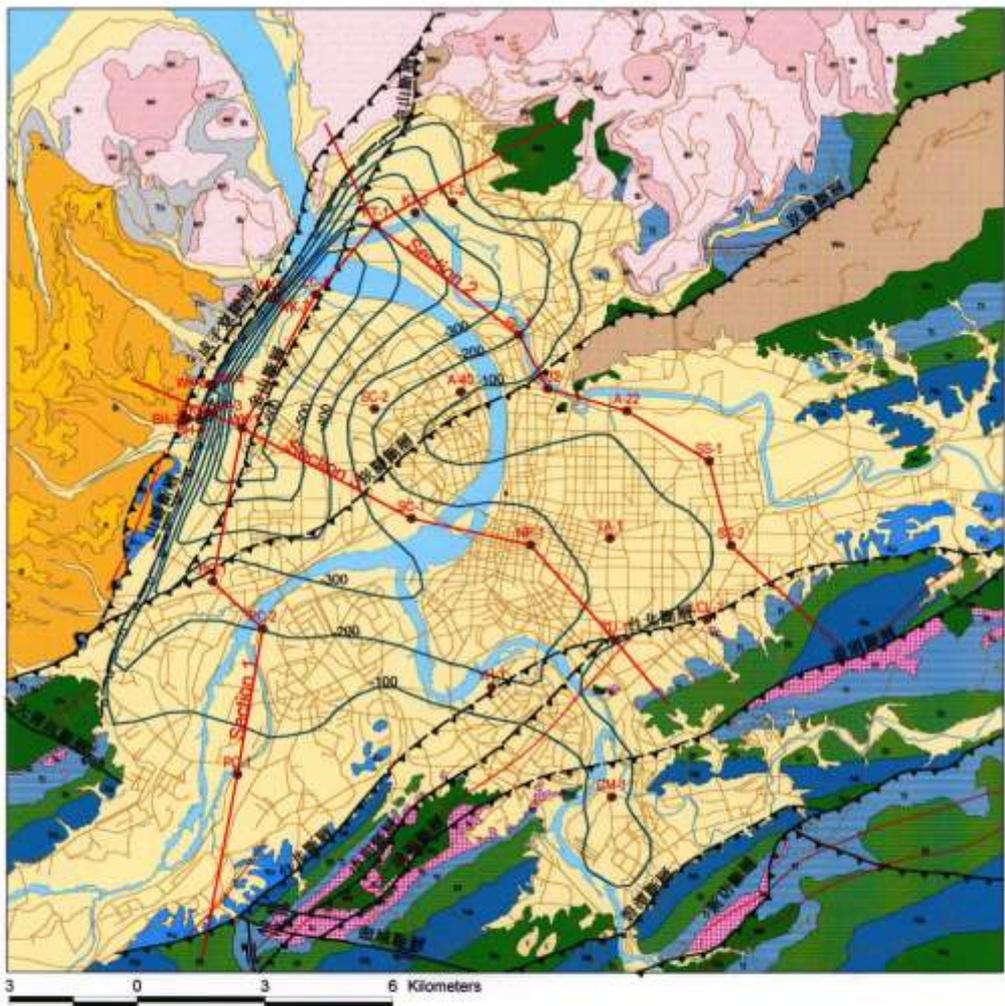
Depth contour to the basement top
From deep drilling.
Central Geol. Surv.

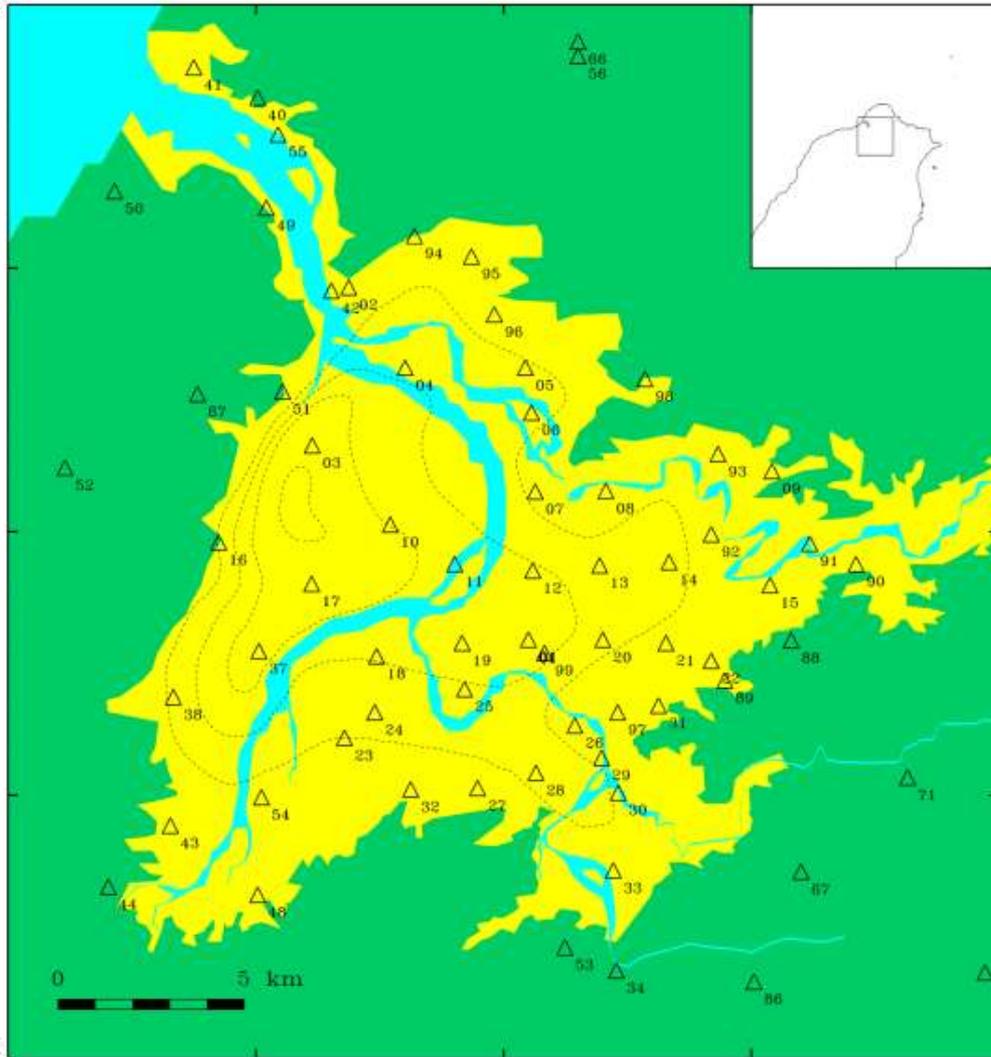
TSMIP - TAIPEI AREA

Locations of the strong motion stations in Taipei area. Numbers indicate the station codes of TSMIP network (CWB).

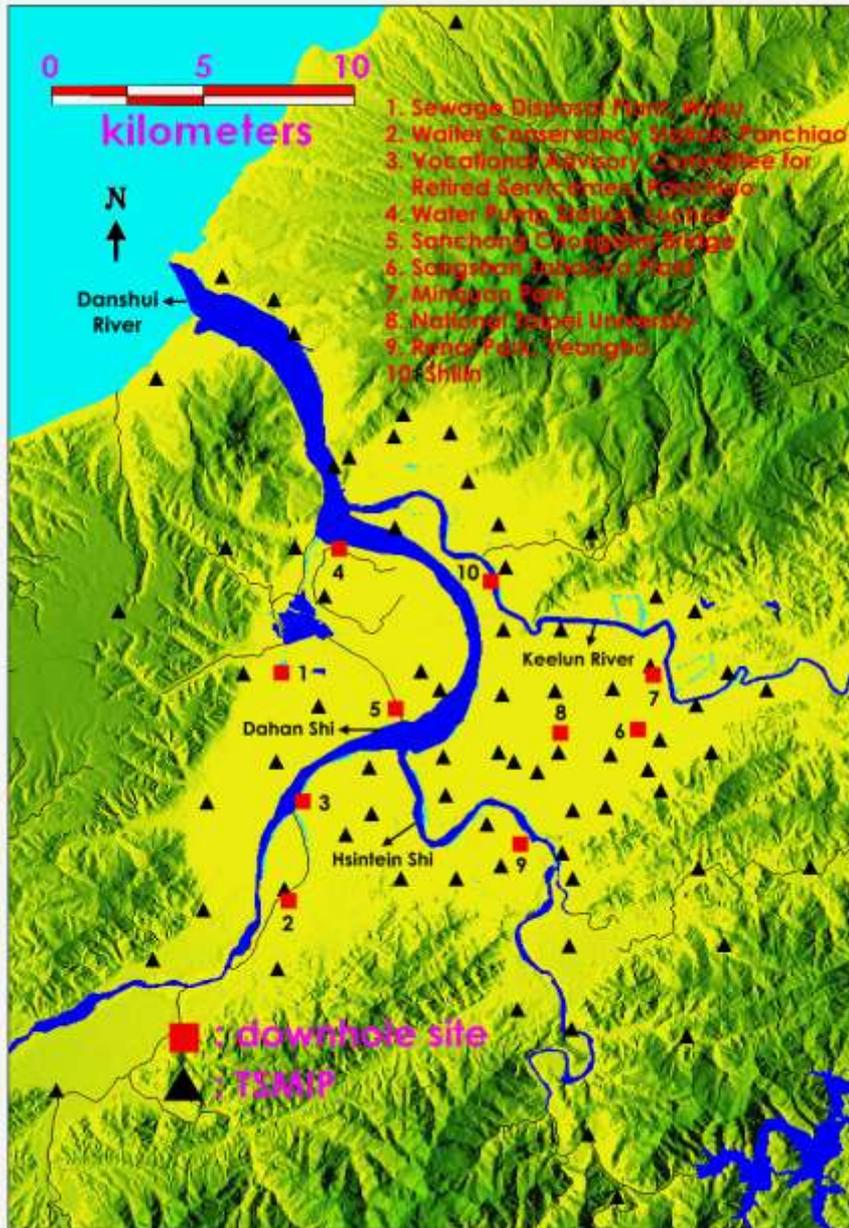
Downhole Arrays in Taipei Basin

A plan conducted by the CGS, MOEA since Aug. 1991. This project proposed the installation of downhole arrays in Taipei Basin one site per year to analyze the variation of seismic waves propagated from basement to ground surface.

In February 2002, the CGS finished the research project and removed it to IES. After few months rearranging and planning, four additional downhole sites were under consideration.

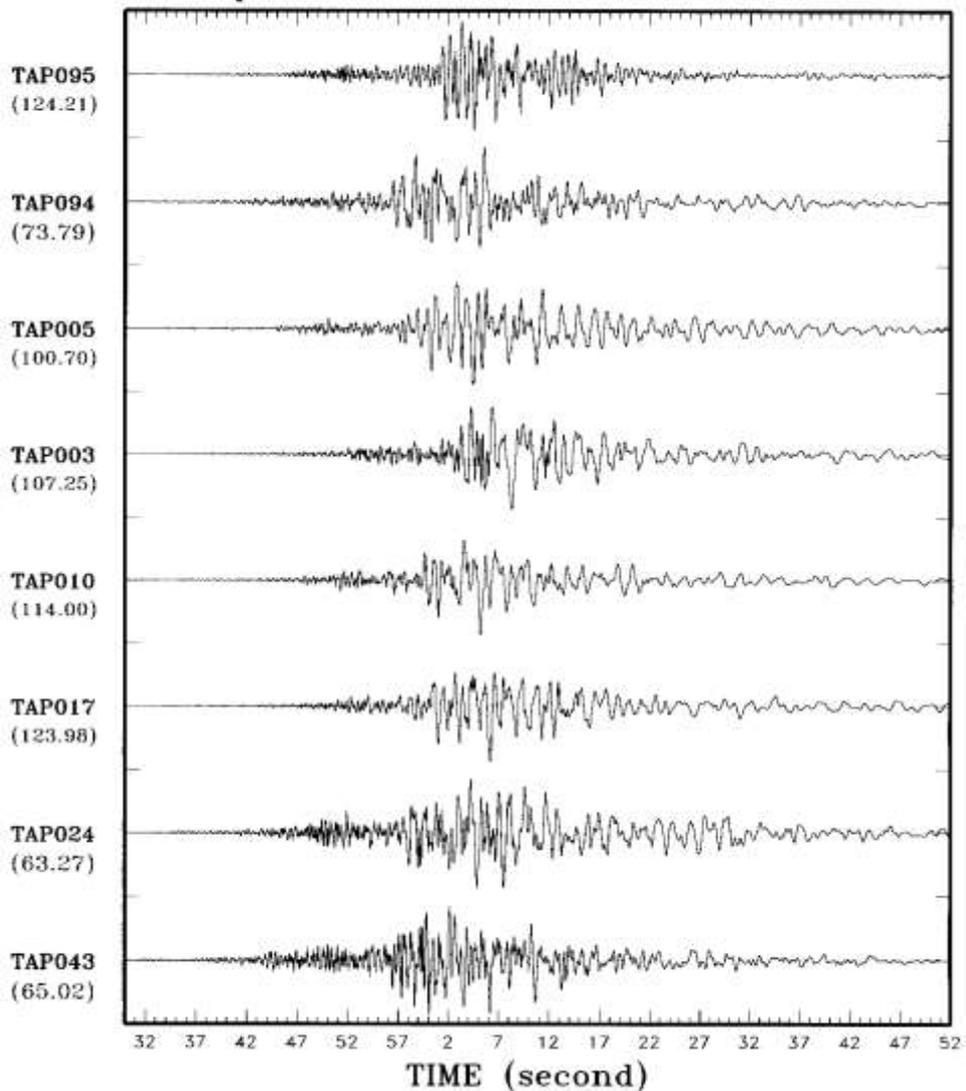
ACCELEROGRAM OF EQ. 1999-9-20 17:47 UT
T Component

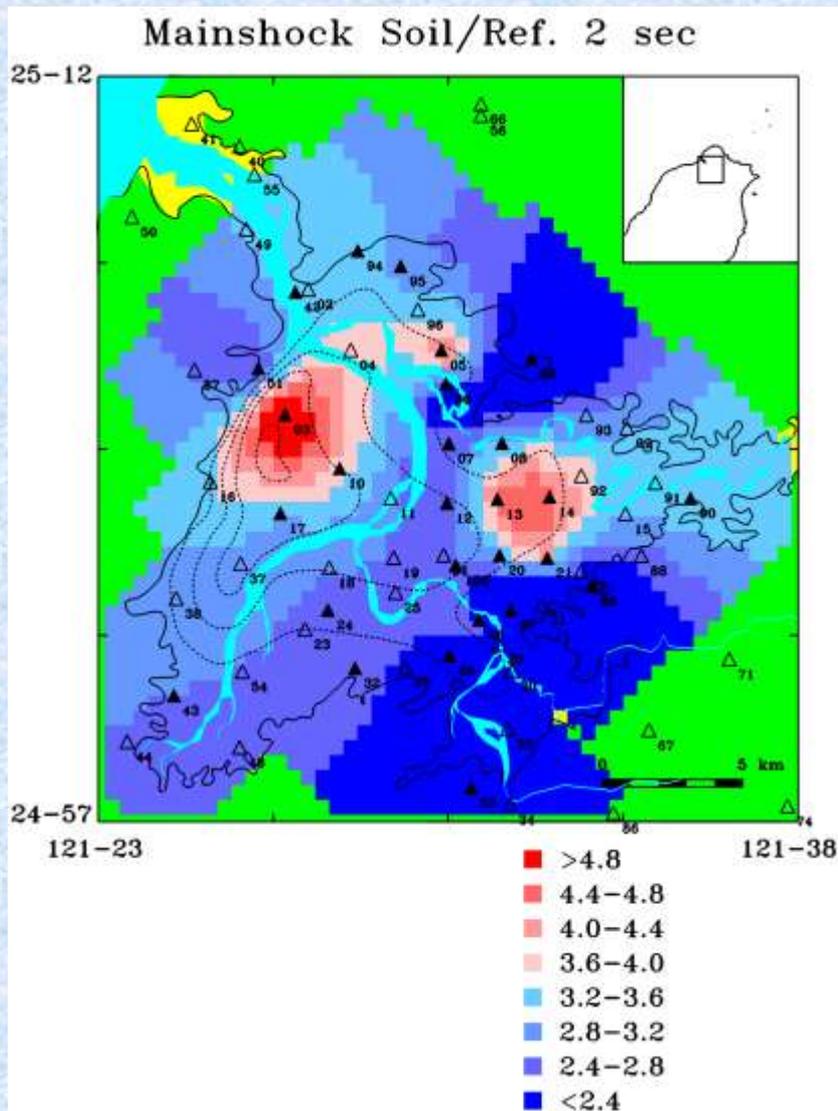
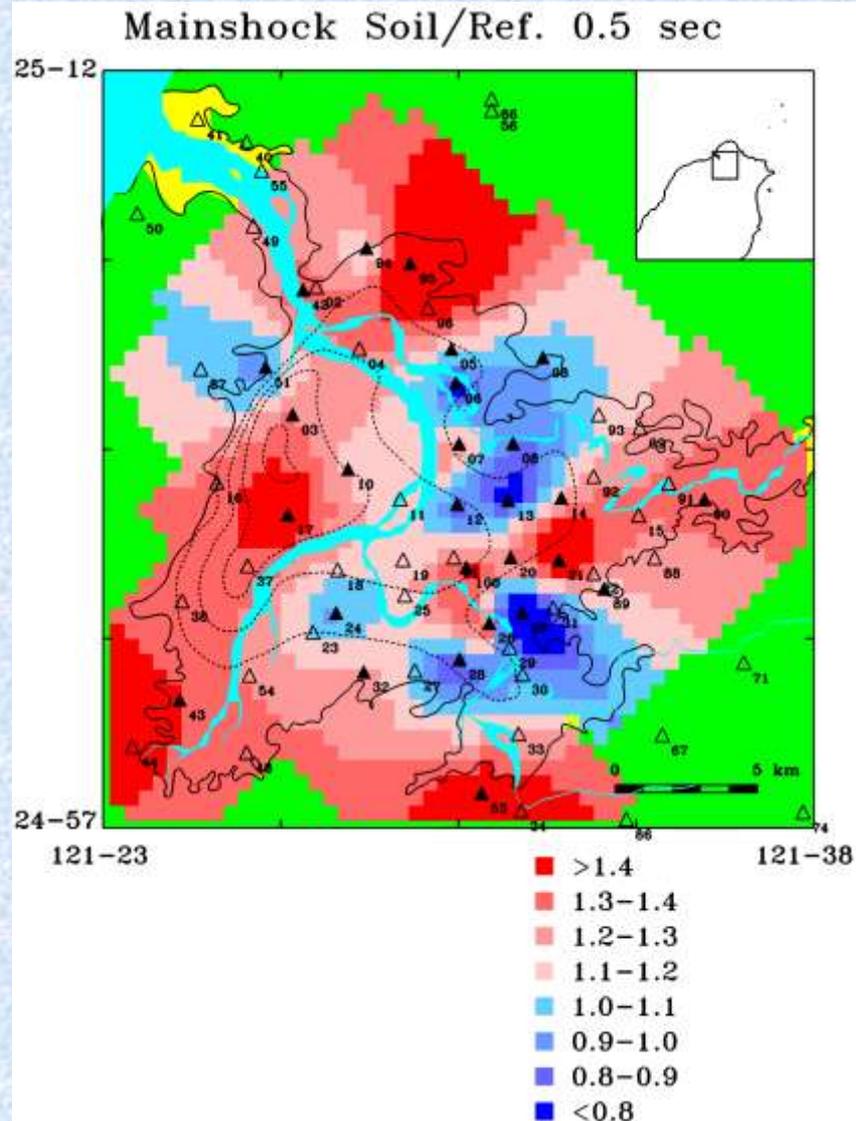
Spectral ratio contours of the Chi-Chi earthquake in the Taipei basin.

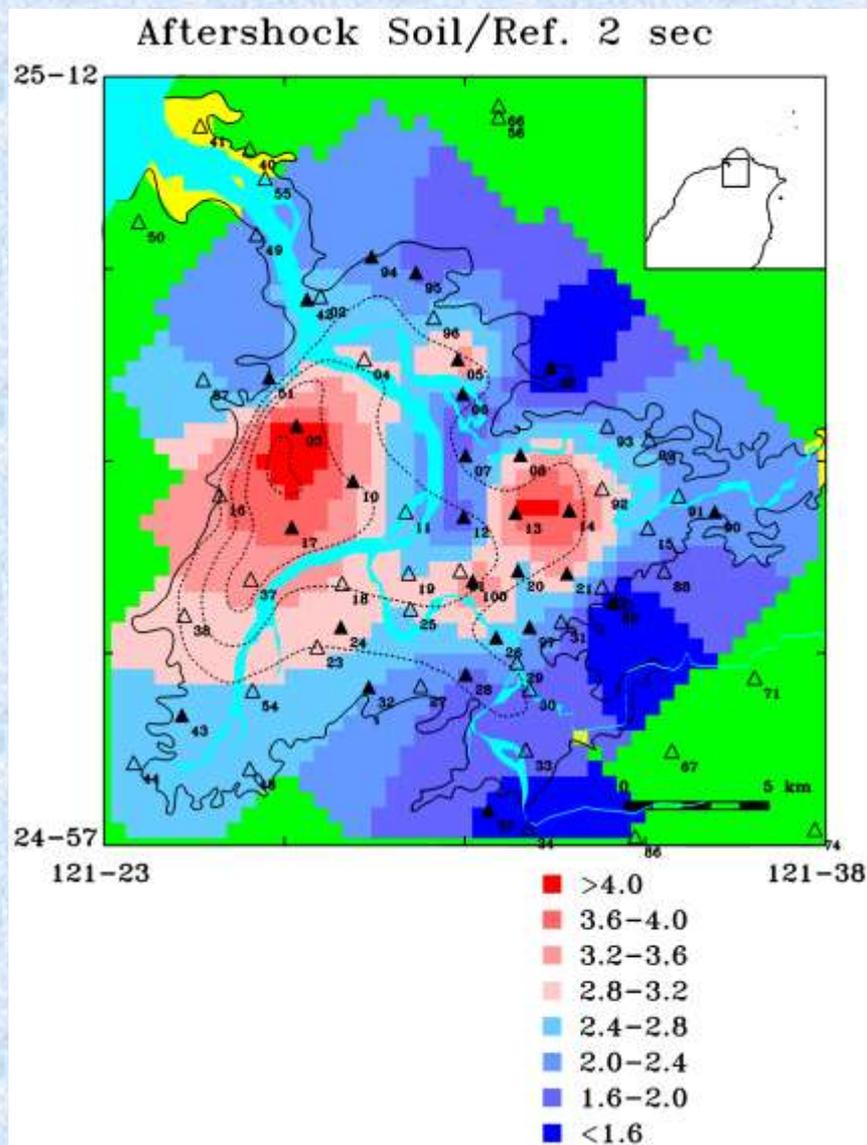
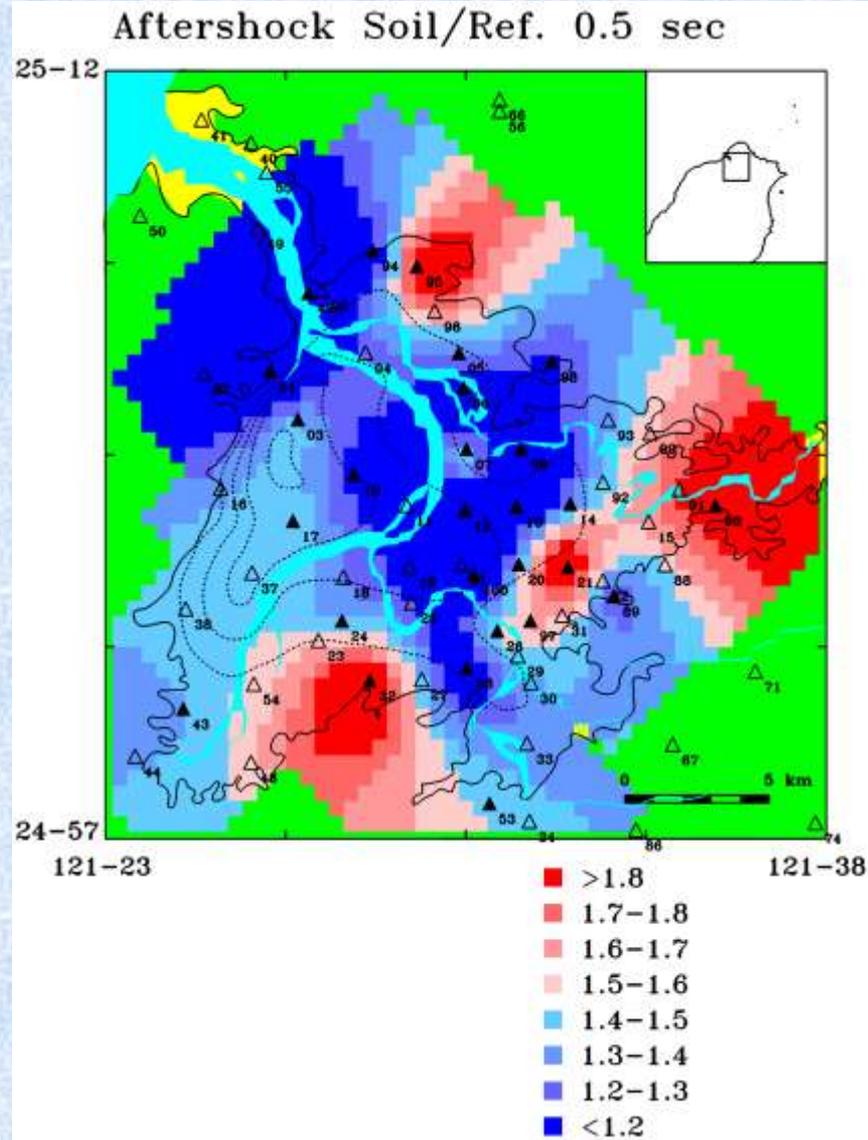
Spectral ratio contours of the Chi-Chi aftershocks in the Taipei basin.

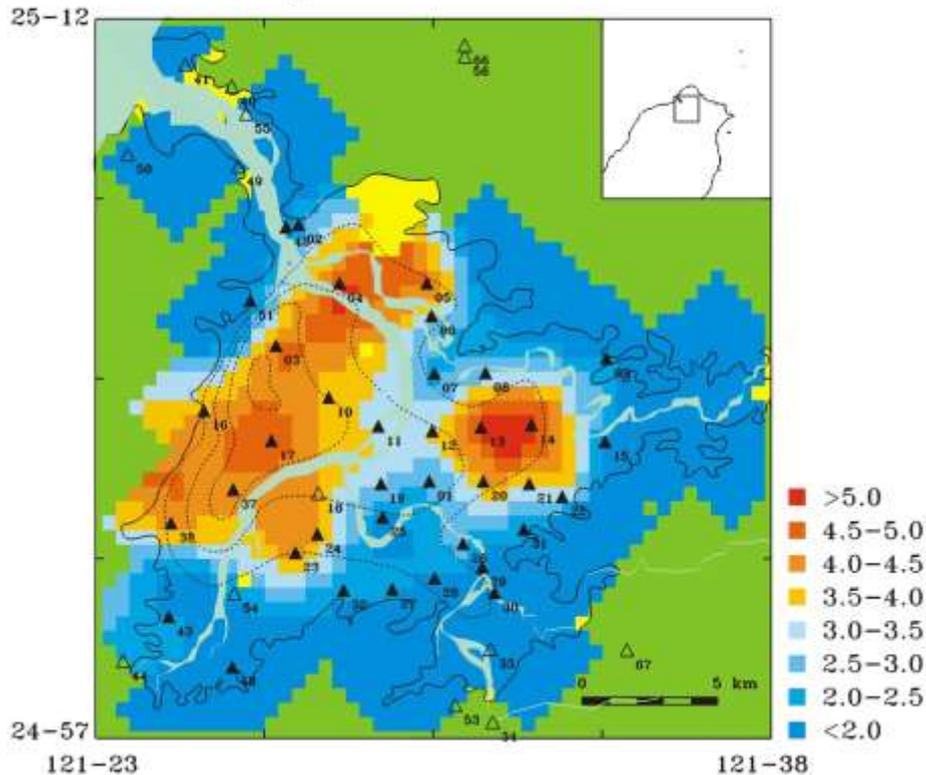
Soil/Rock - 2.0 sec

Mean spectral ratio obtained before the Chi-Chi earthquake. The earthquake used are occurred at south-eastern and eastern direction of the Taipei basin.

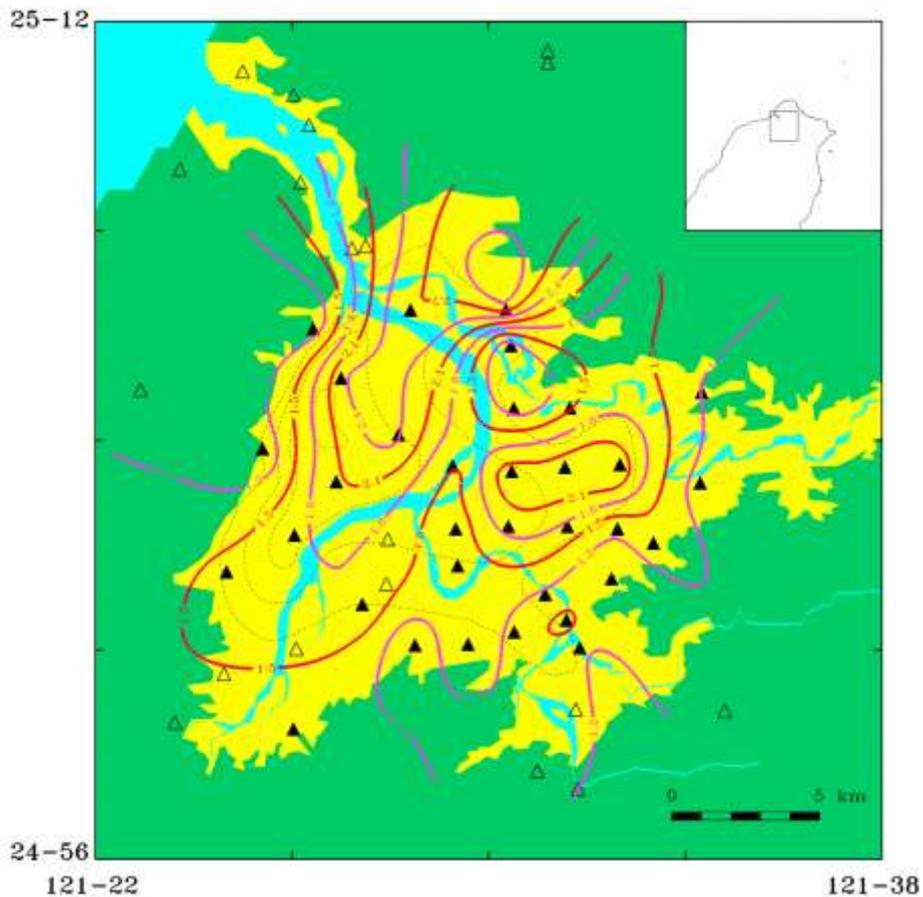
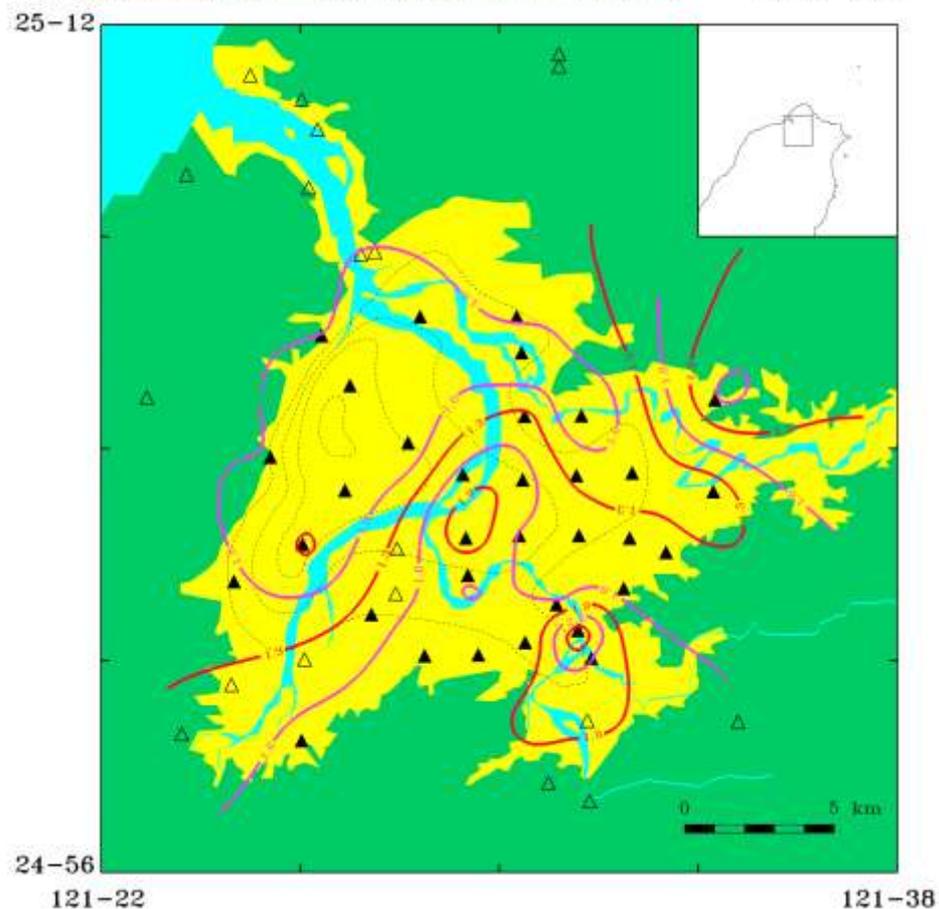
TSMIP測站微地動資料於2秒與0.5秒之Nakamura比等值圖。

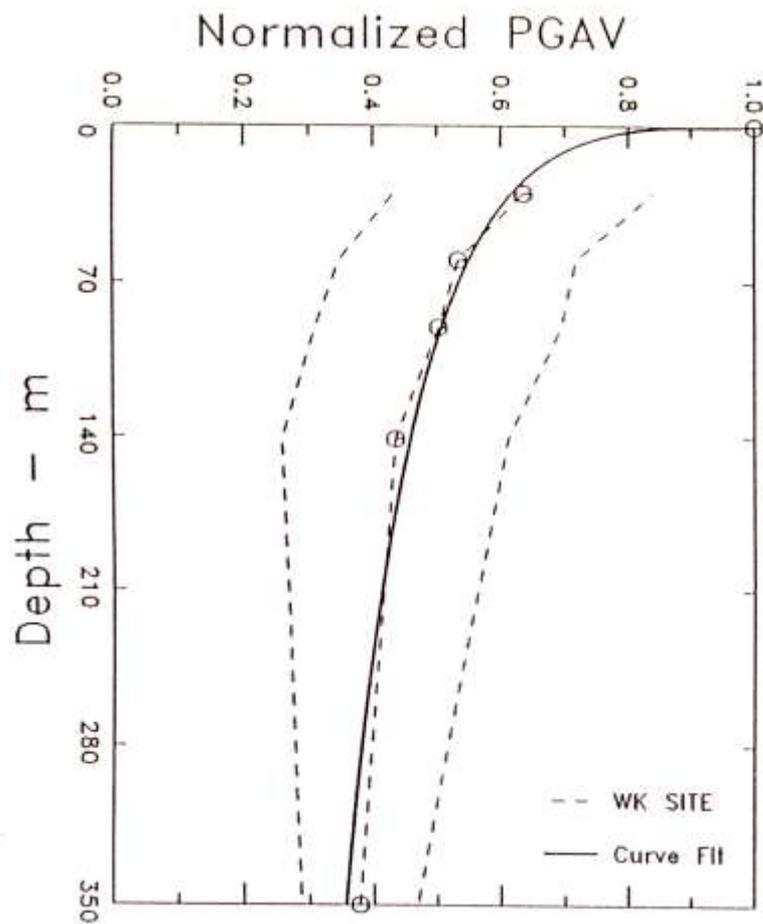
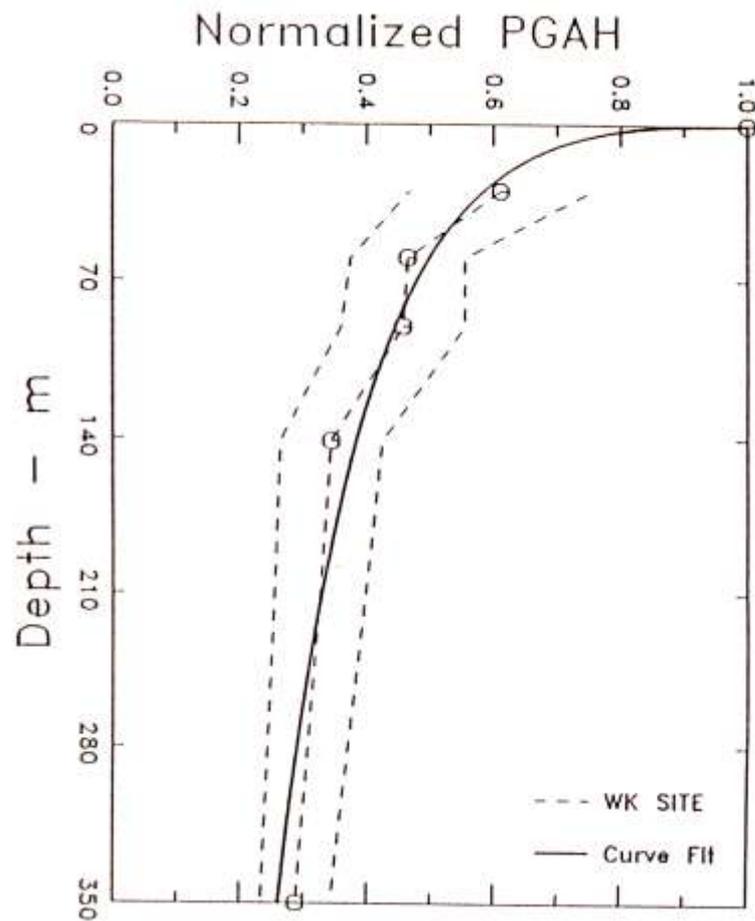
WK

五股抽水站最大地動加速度與地下深度關係圖。

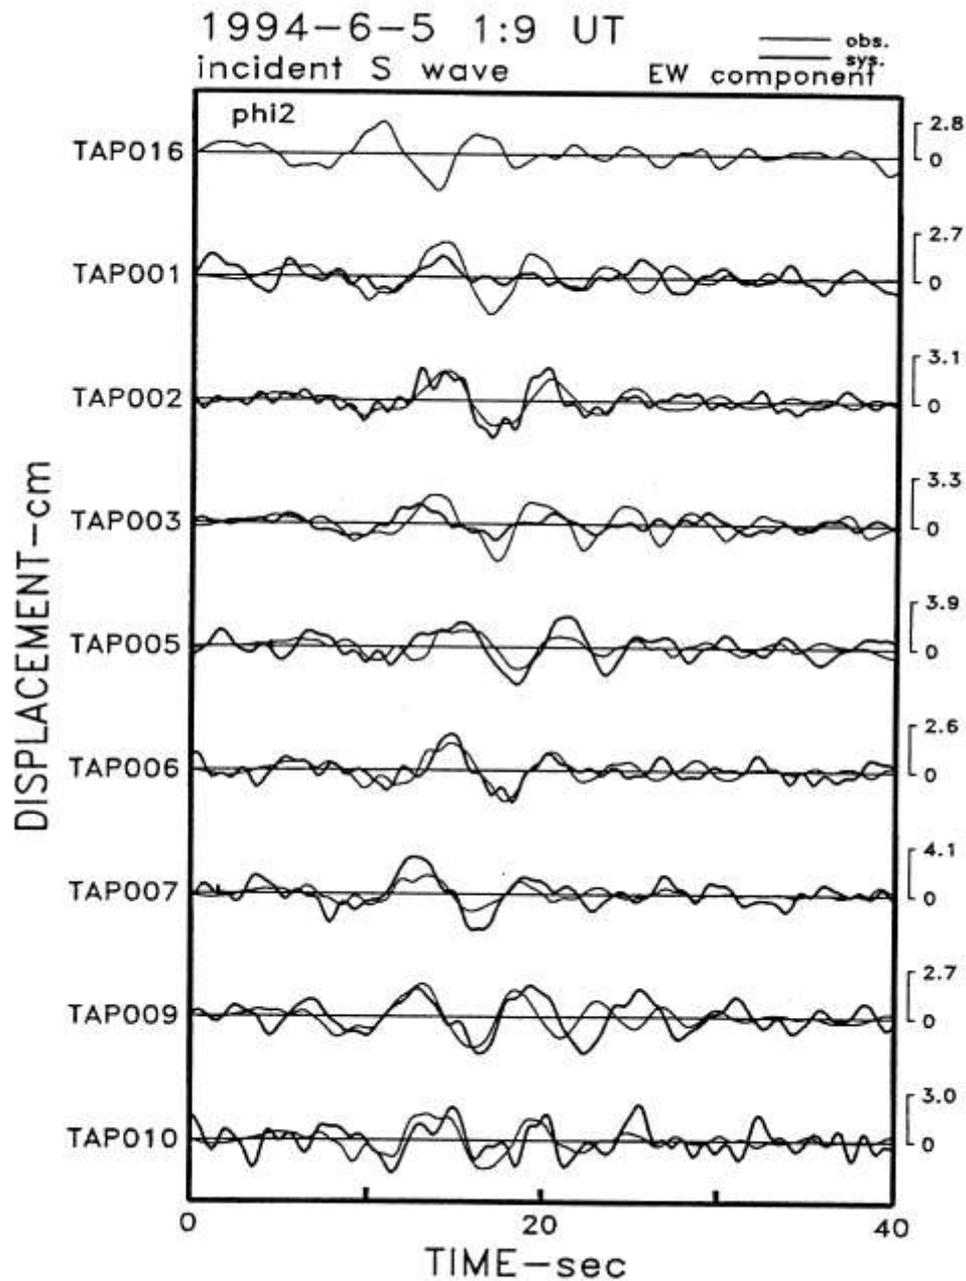
2D Modeling

WK site

0-30m: $Q(f)=3.6f^{0.96}$

30-60m: $Q(f)=7.2f^{0.99}$

60-90m: $Q(f)=10.2f^{1.17}$

90-141m: $Q(f)=40.7f^{1.24}$

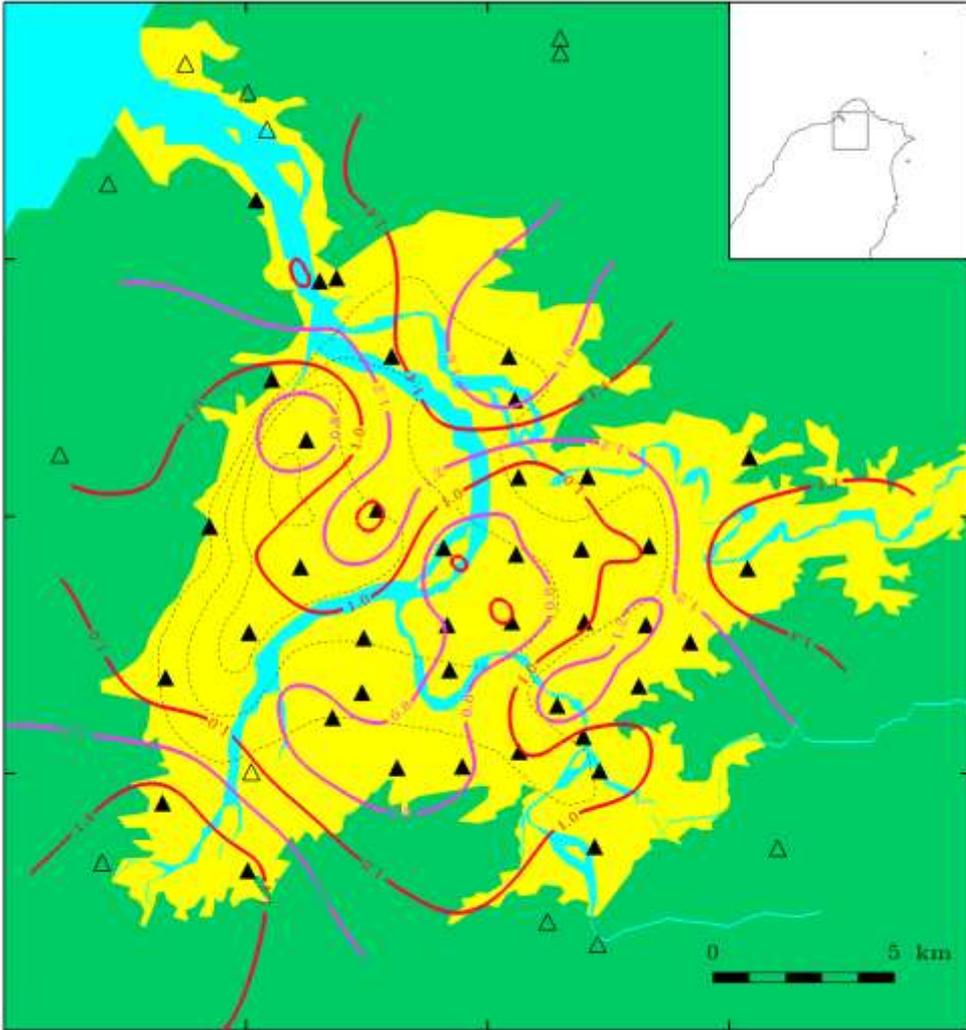
3D Modeling - 2 sec

三維理論模擬TSMIP
地表與參考站
(TAP016)
於2秒之頻譜比等值圖

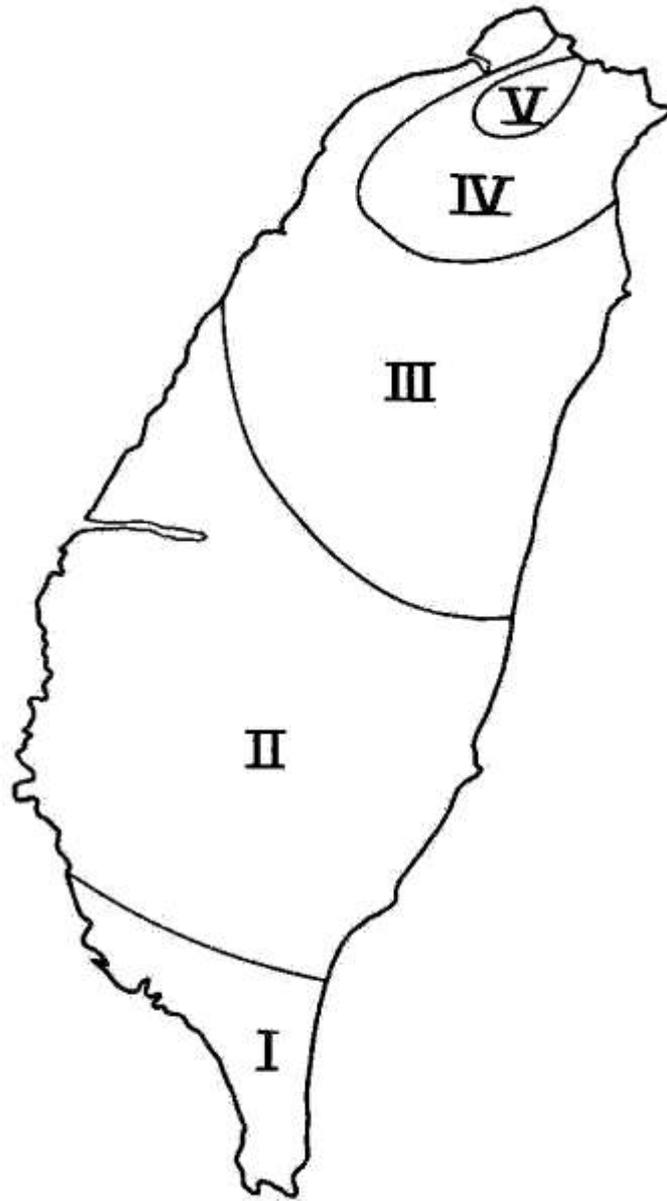
1909年4月15日所發生地震之等震度圖 (Hsu, 1971)

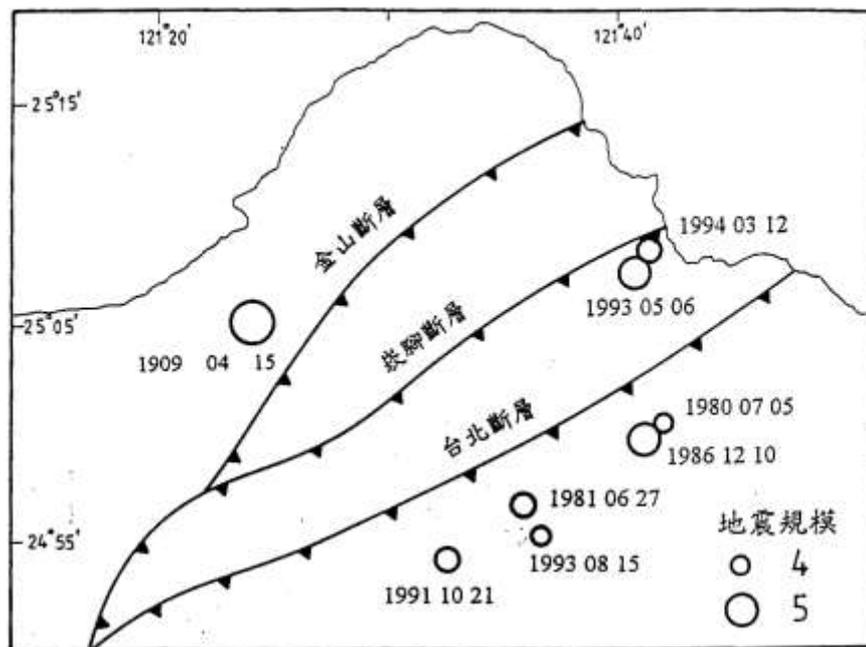
圖四 台北地震與台灣北部隱沒帶關係示意圖 (M ≥ 4)
 (x: 震源、•: 震央)

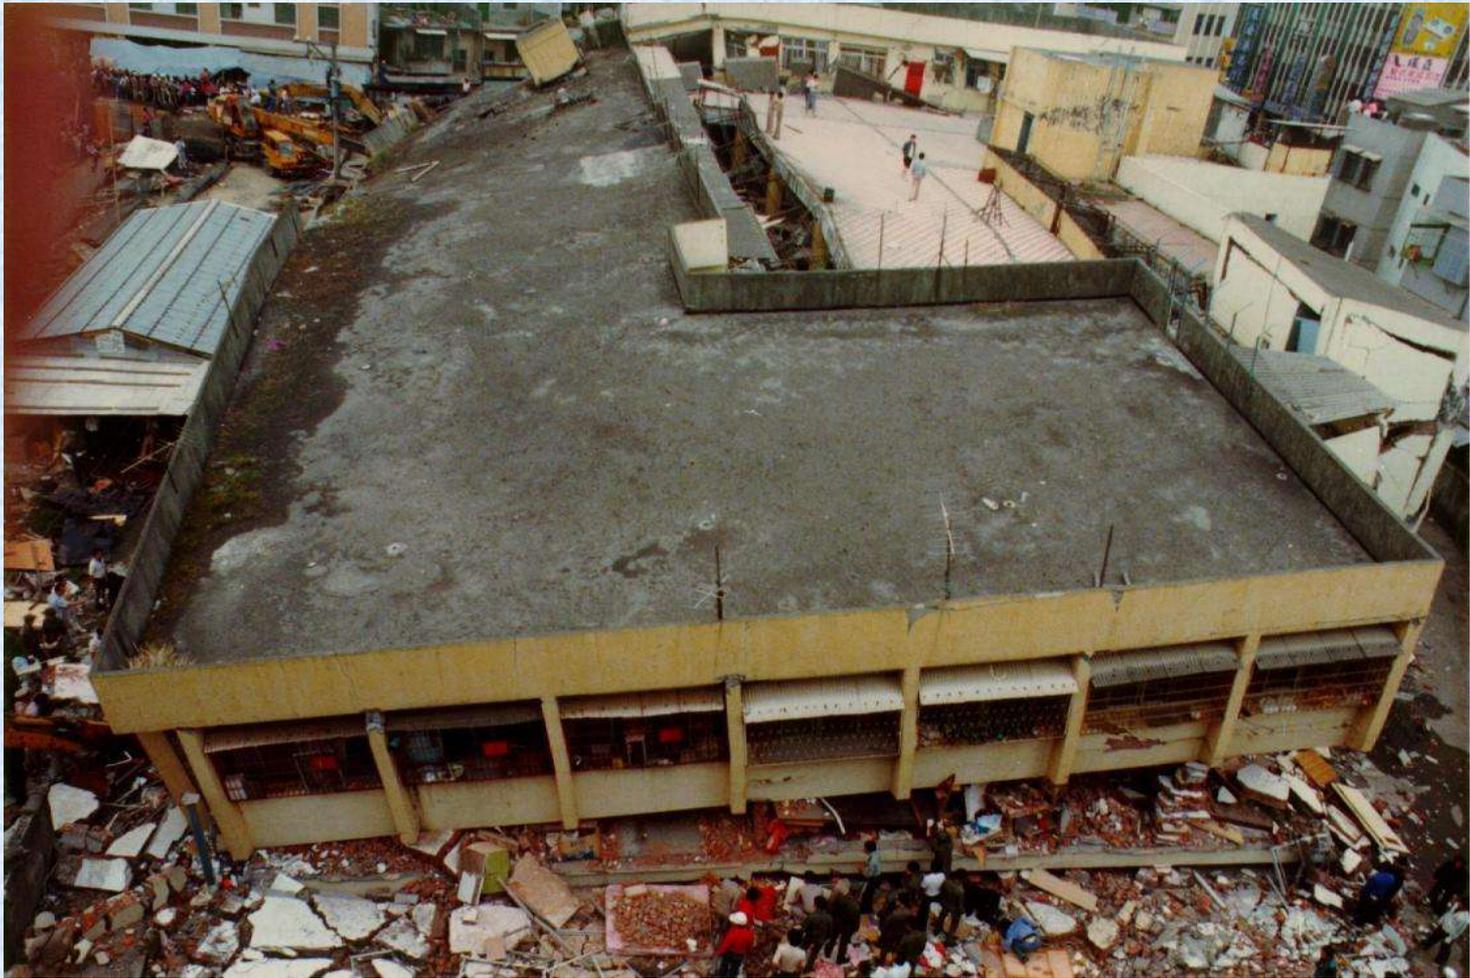
3F

台北縣中和市員山路之華陽市場，原為三層多柱少牆鋼筋混凝土的市場建築物，由於2、3層改為住家後砌築了許多磚造外牆與隔間牆，使得建築物成為上剛下軟的結構，加上過大的超載，在耐震上十分不利。在此次地震襲擊下，幾乎大部份一、二樓的支柱折斷，造成12人死亡，數十人受傷的慘劇。

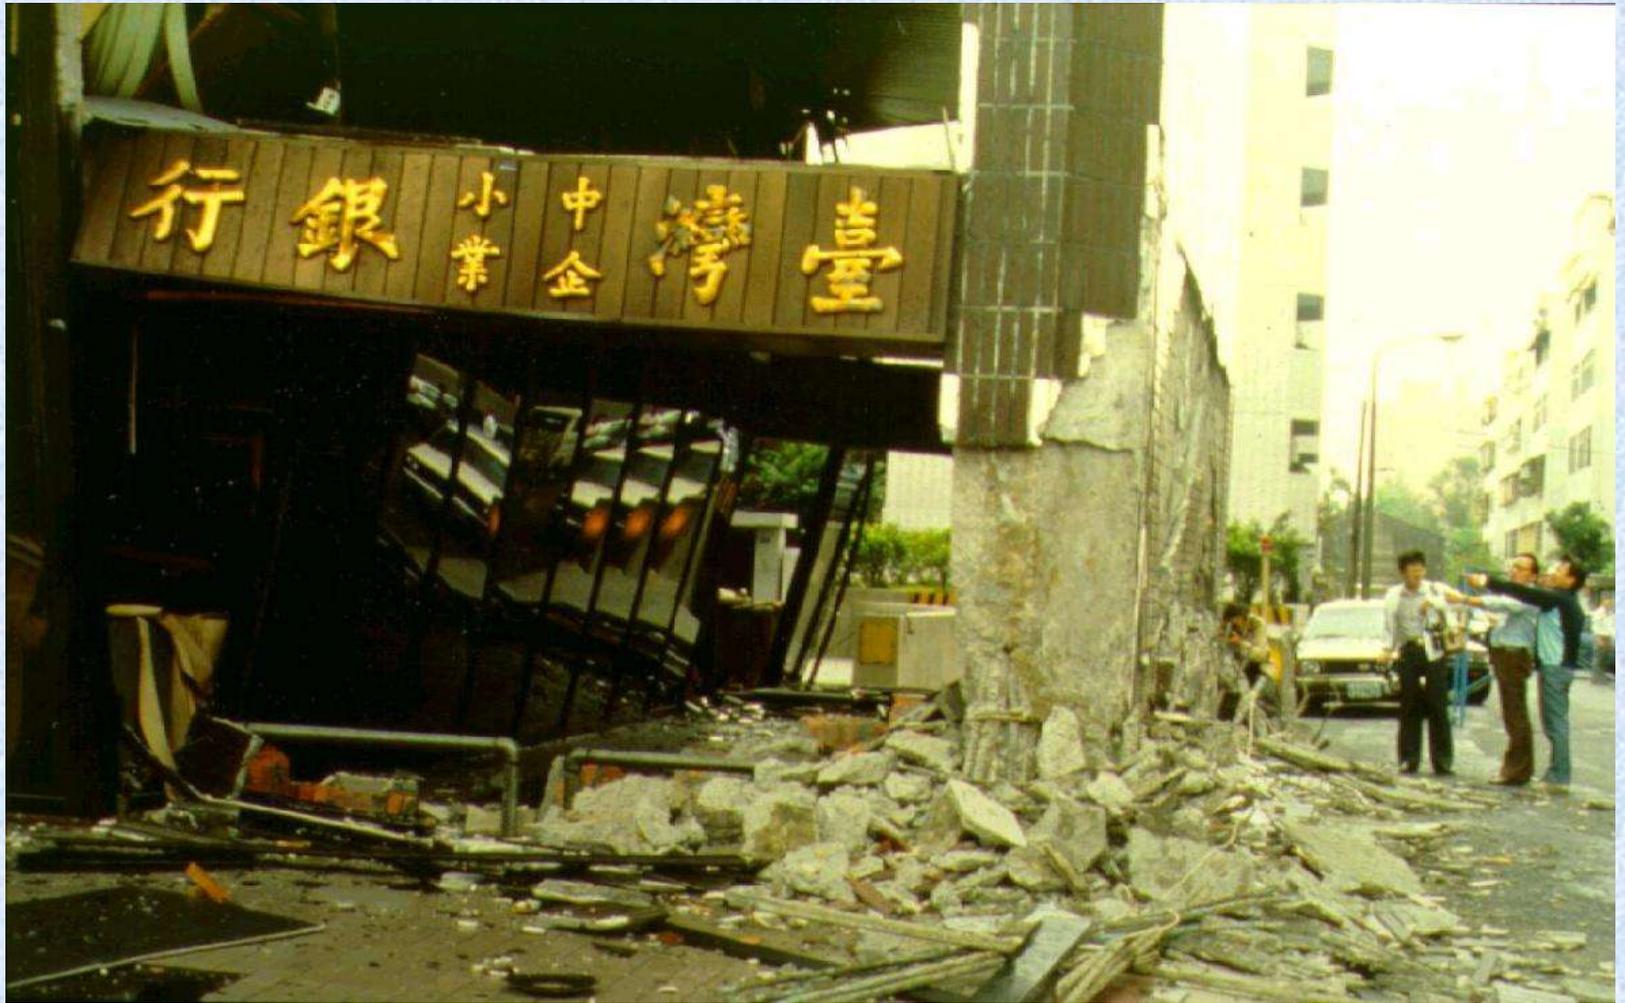
14F

台北市復興南路一段某大廈，一樓剪力牆腳及牆邊構材部份被壓碎，鋼筋暴露且扭曲變形，牆面呈斜向之剪力龜裂，一、二樓間之混凝土樓板破裂並下陷。

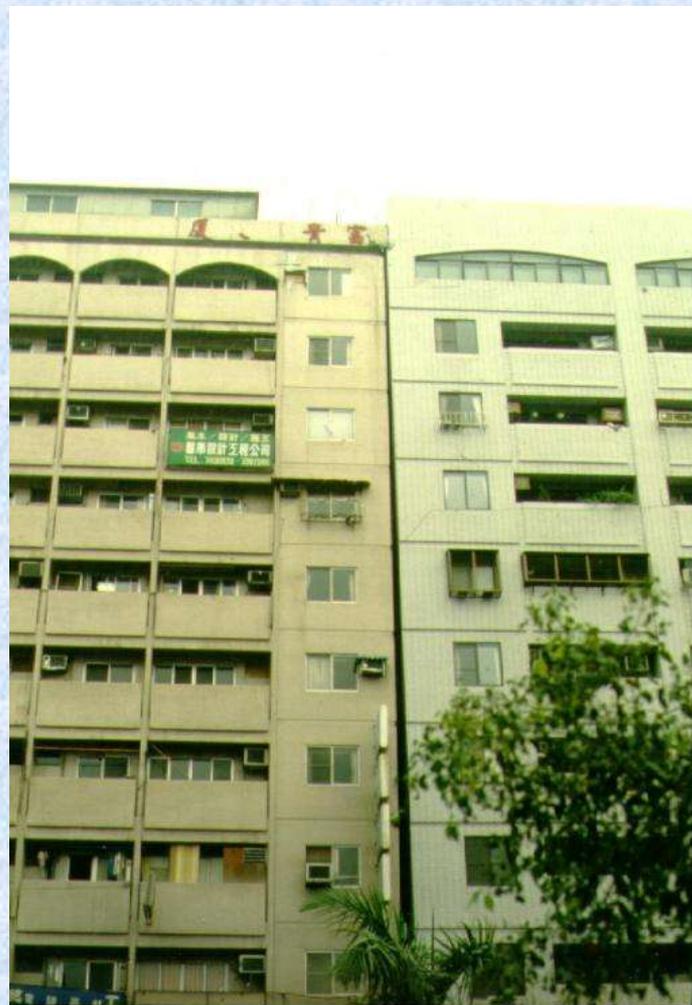
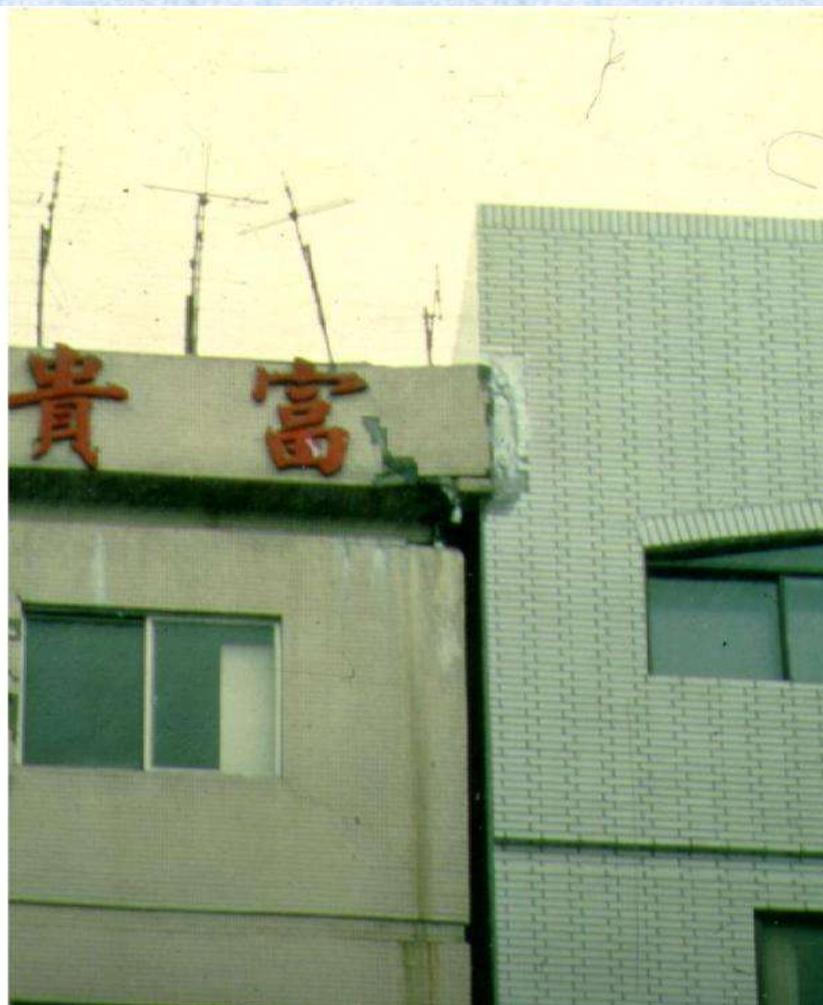
12F

台北市二棟大廈因棟距過近且振動頻率不相同，造成頂樓碰撞受損，5月20日花蓮地震受損後修補的位置再次損壞。

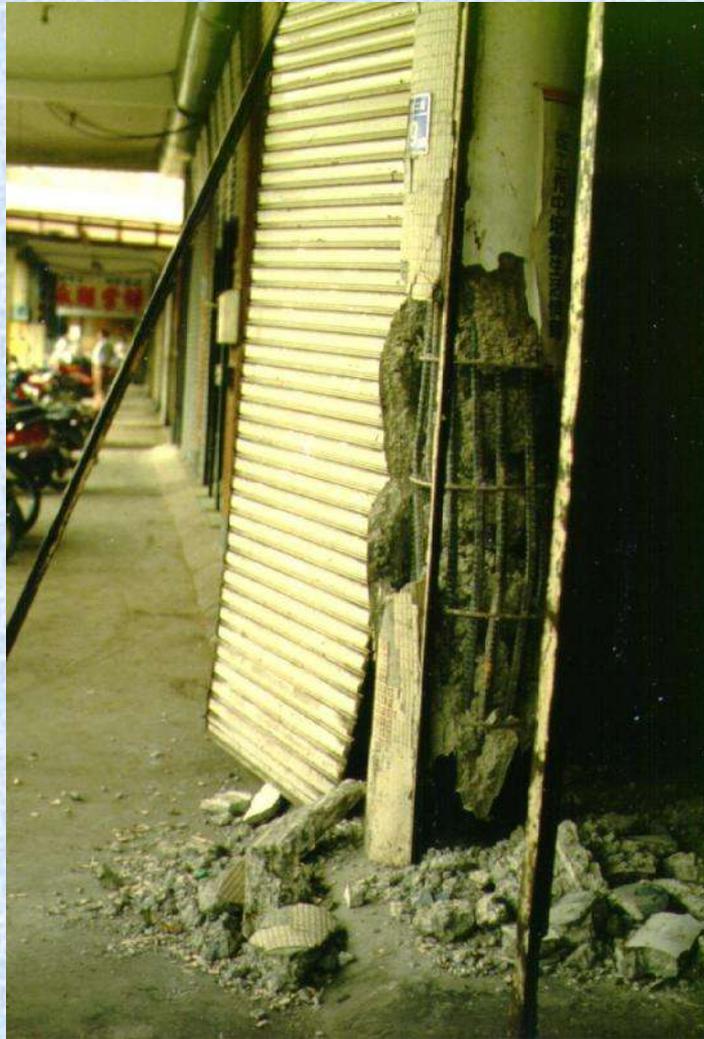
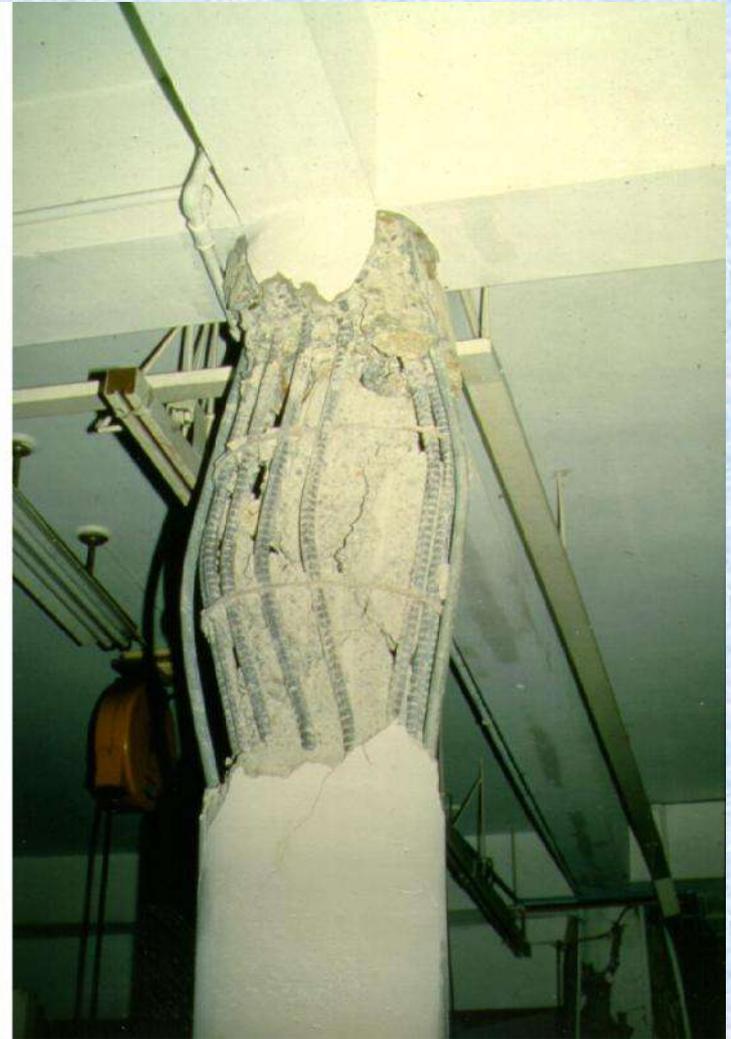
12F

台北市基隆路某汽車公司，門前與建築物中之鋼筋混凝土柱暴裂，鋼筋扭曲變形。
