**The 2nd Annual Meeting of the Strategic
Chinese-Korean-Japanese Cooperative Program
Jeju island, Korea, 2012/10/29-31**

Site Amplification Study **— Case of Taipei Basin —**

Kuo-Liang Wen
NCU, Taiwan

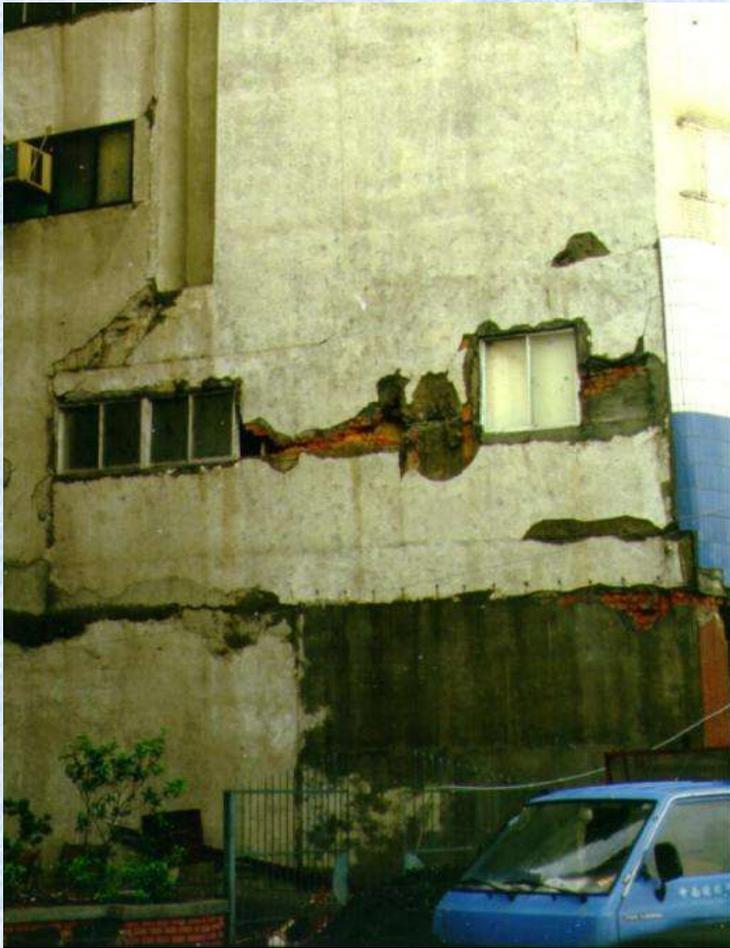
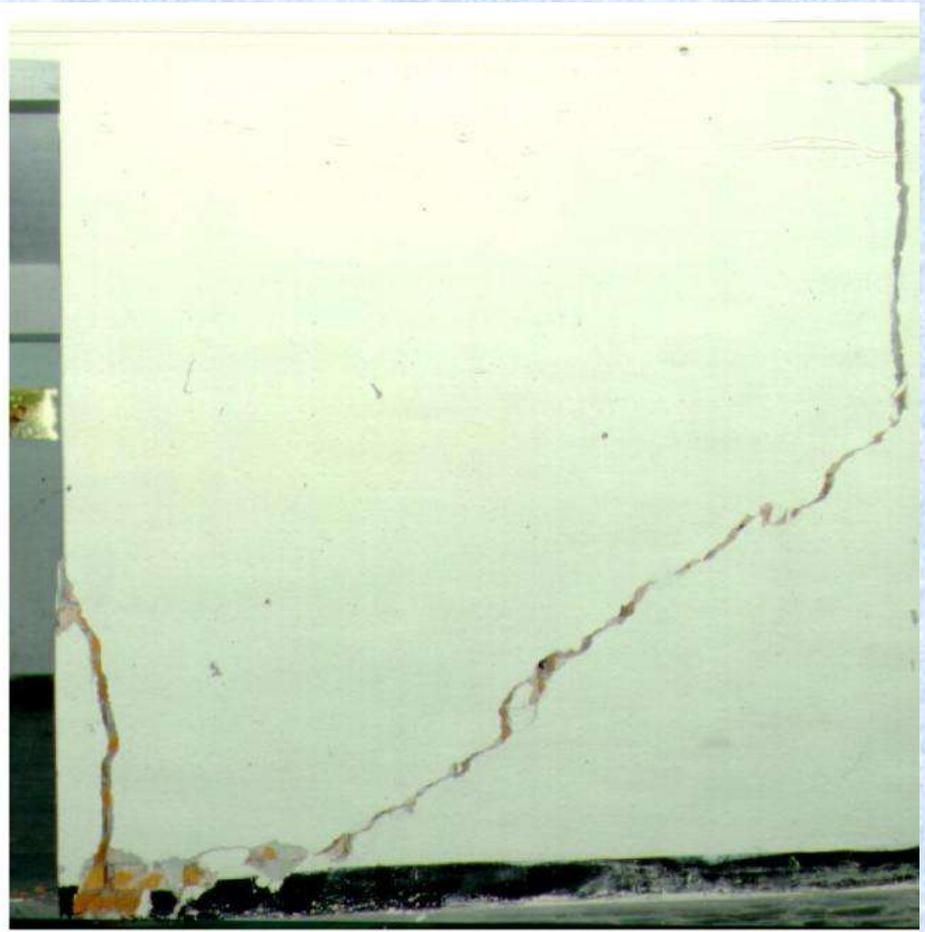
13F

台北市基隆路一段某大廈外牆破壞情形，該大樓自9樓以下
電梯間大樑、樓梯間牆壁，大樓外牆均發生龜裂，部份樑
柱牆壁龜裂處之水管斷裂；8樓之牆壁呈斜向之剪力破壞。

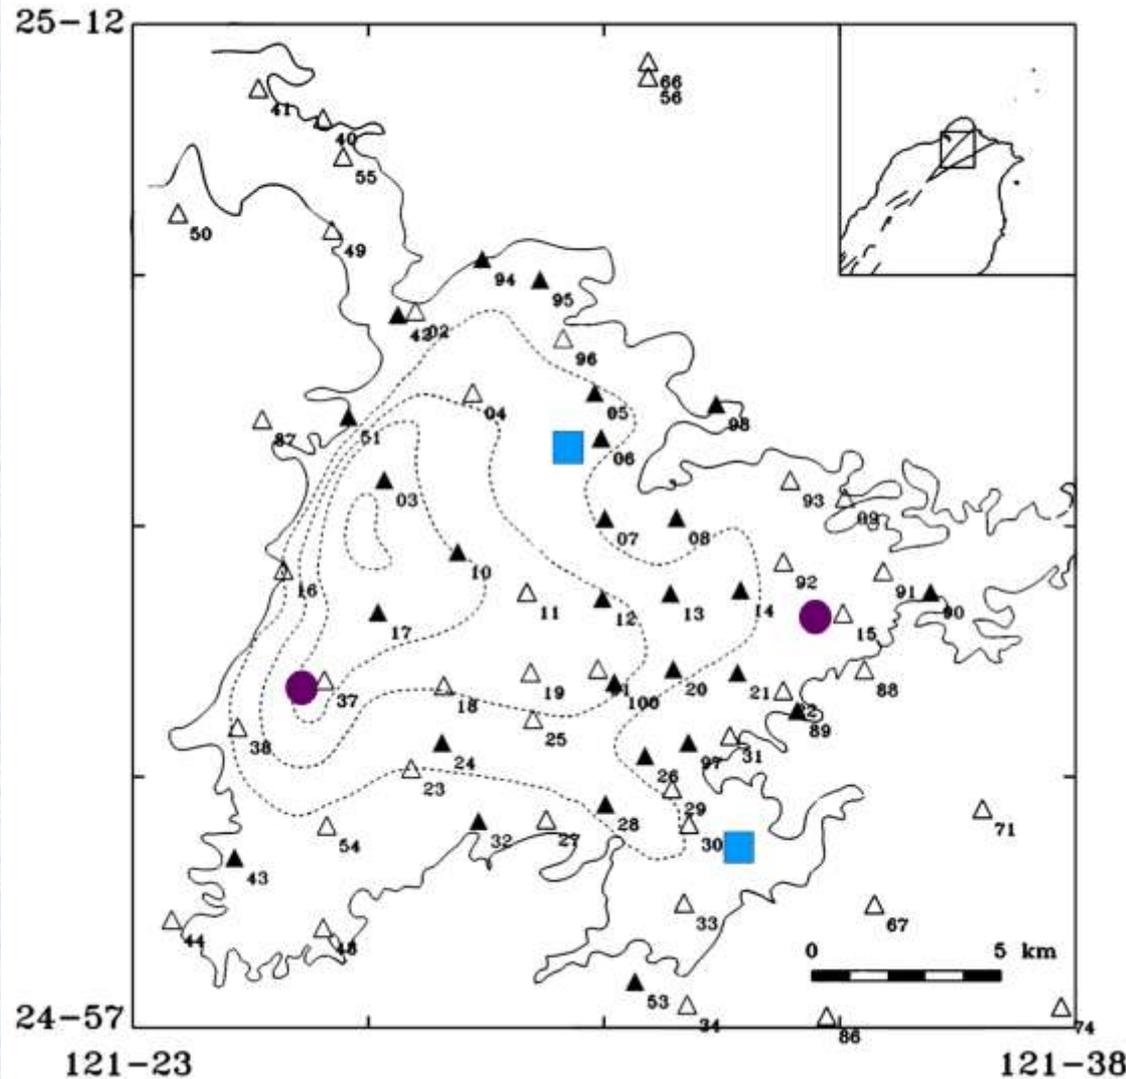
Distribution of the collapsed buildings due to the 1999 Chi-Chi earthquake

During the 1986, Hualien earthquake and 1999, Chi-Chi earthquake, there are some buildings damaged. By comparing between the distribution of damaged buildings and spectral ratio contours, we found that the patterns can be correlated.

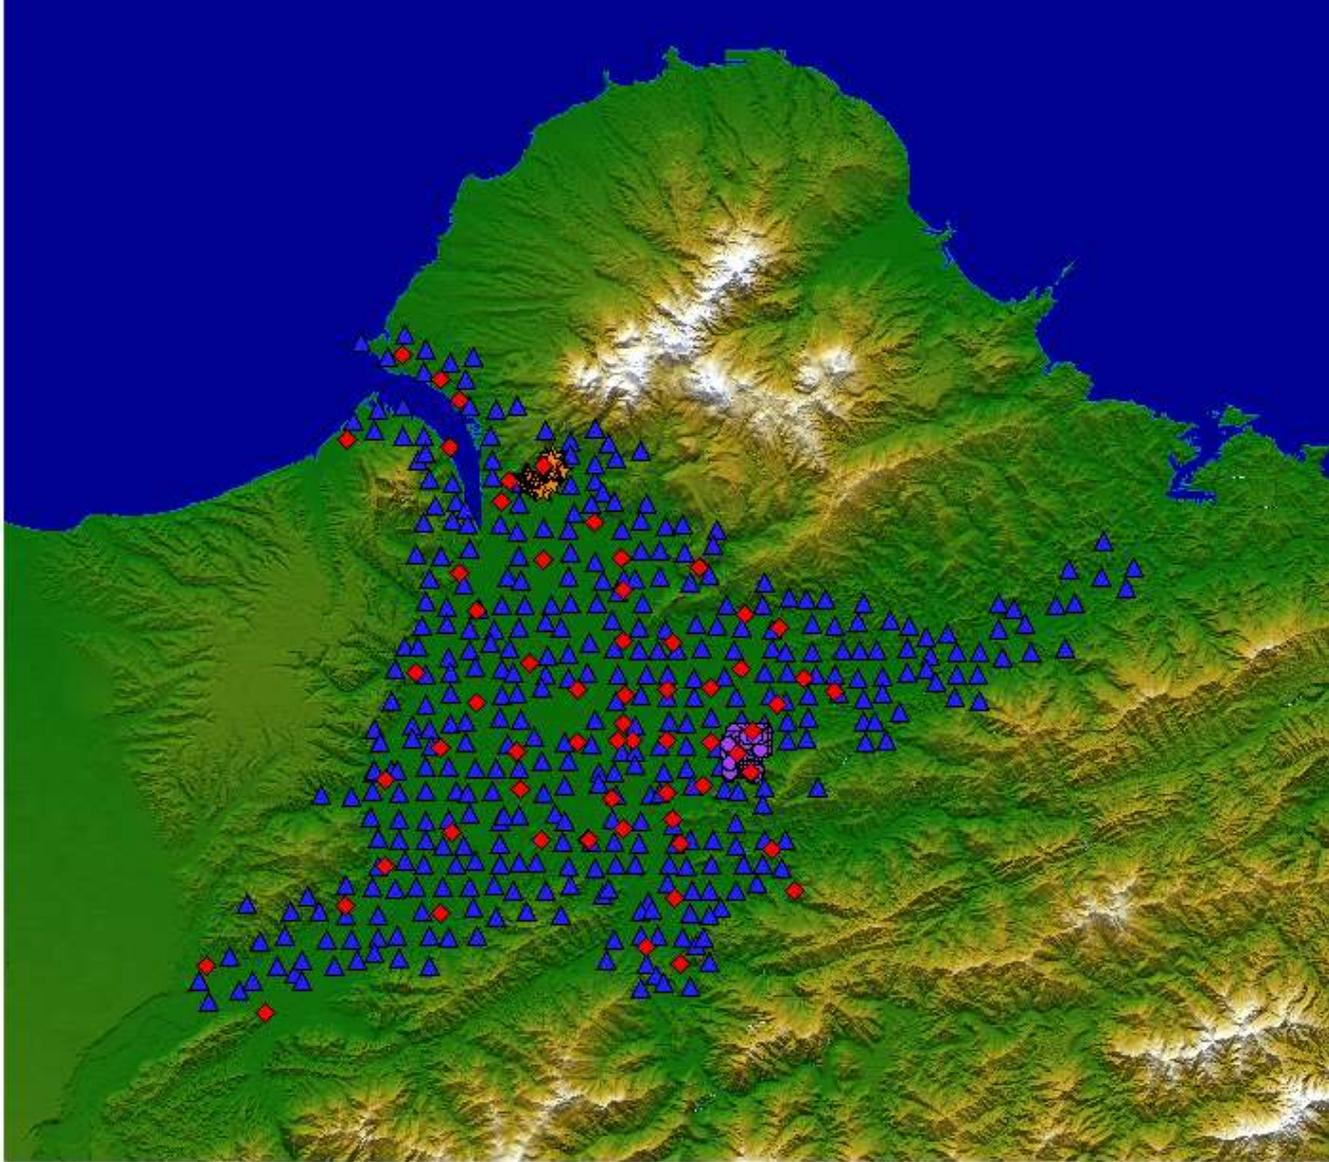
▲ Strong motion station
: 69

▲ 500 stations

Interval ~ 1 km

Locations of the microtremor survey points in the Taipei area. Red symbols indicate the strong motion stations.

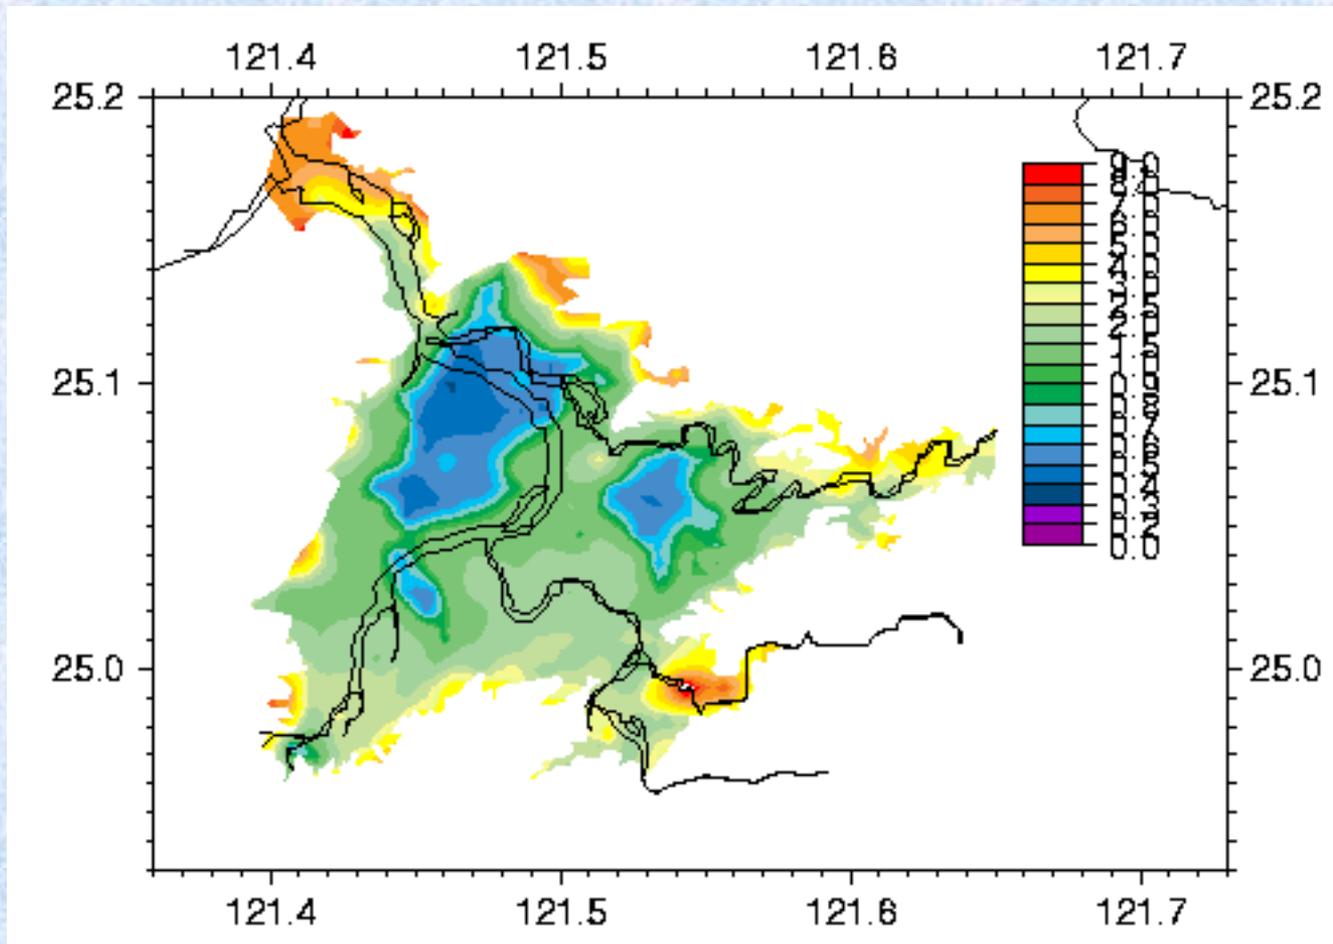
Dominant frequency contour in the Taipei basin area, result from the H/V ratio of dense microtremor survey

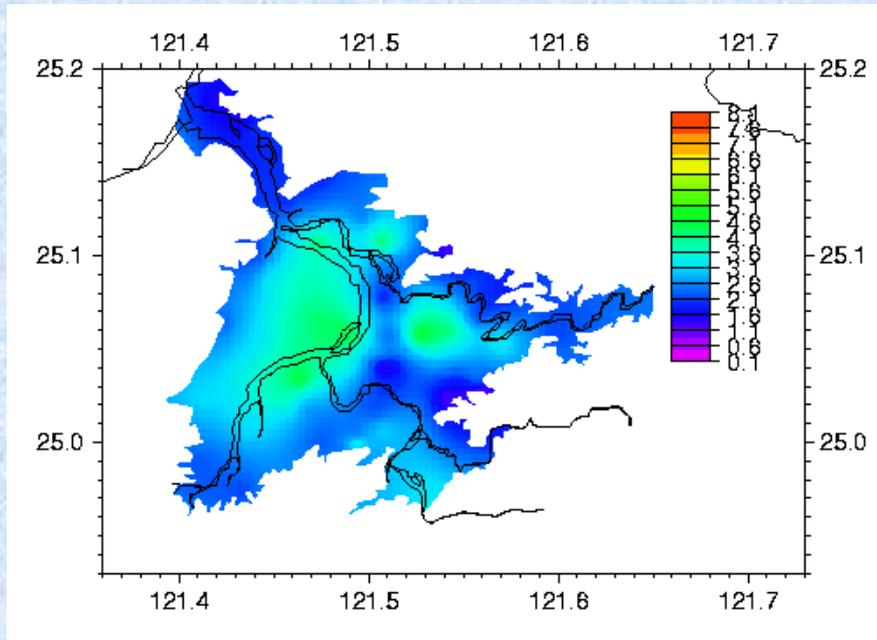
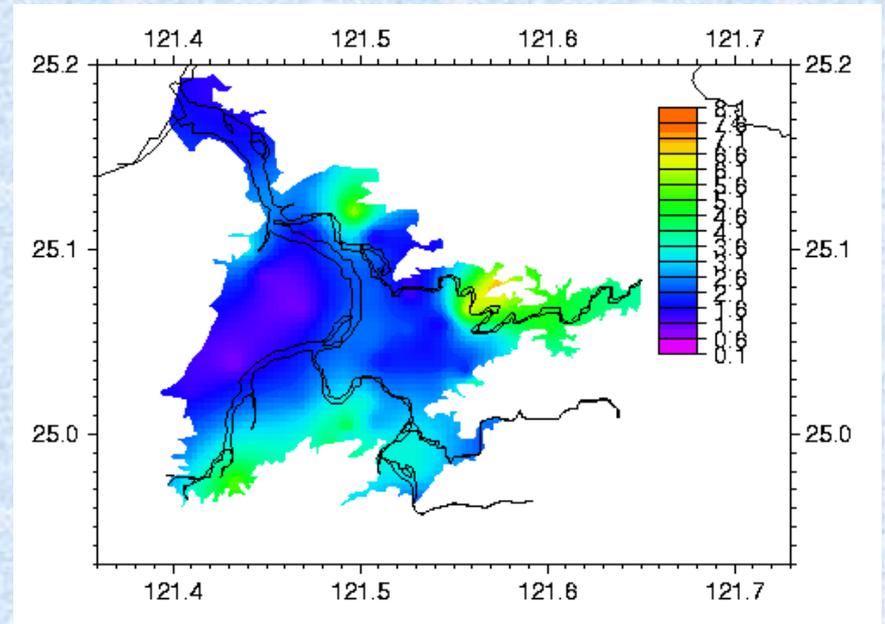
H/V spectral ratio contours at 0.5 and 2.0 Hz.

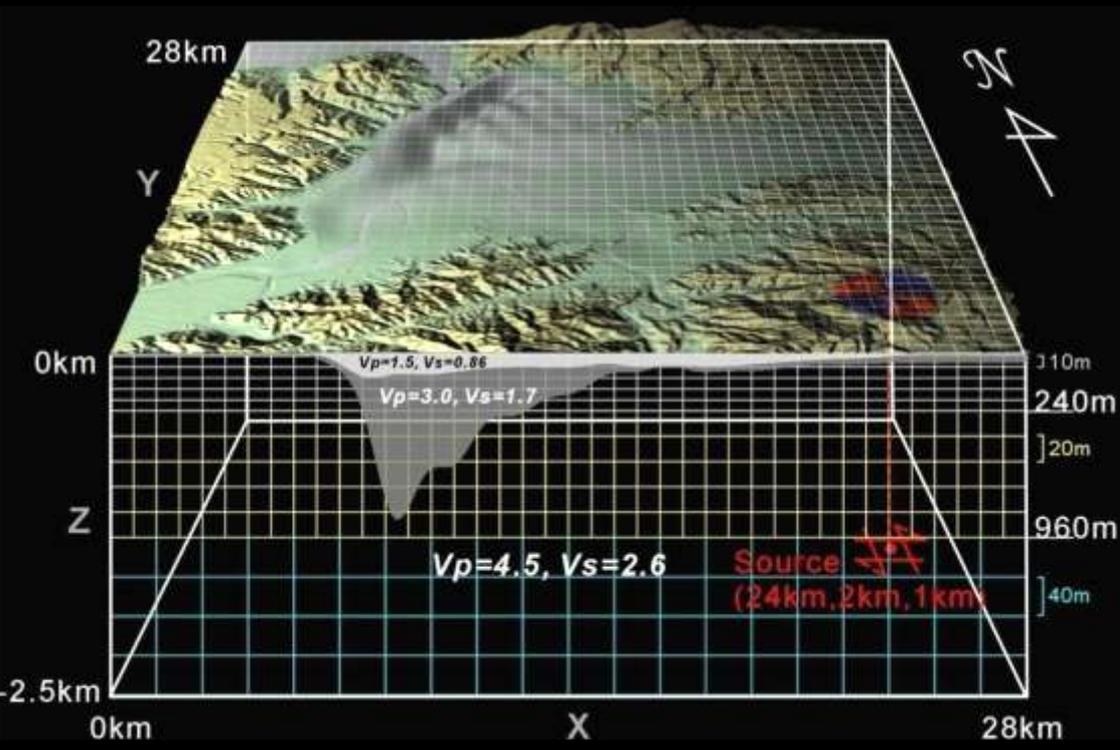
Modeling Parameters

Model dimension (km^3)	28(W) x 28(L) x 2.5(H)
Absorb boundary (grids)	± 100
Source type	Double-Couple
Source location (km)	(24,2,1)
Source time function (sec)	0.16, 0.0, 0.16
Velocity (km/s^2)	
SunShang formation	$V_p=1.5$, $V_s=0.86$
Basin Basement	$V_p=3.0$, $V_s=1.70$
Outside the Basin	$V_p=4.5$, $V_s=2.60$

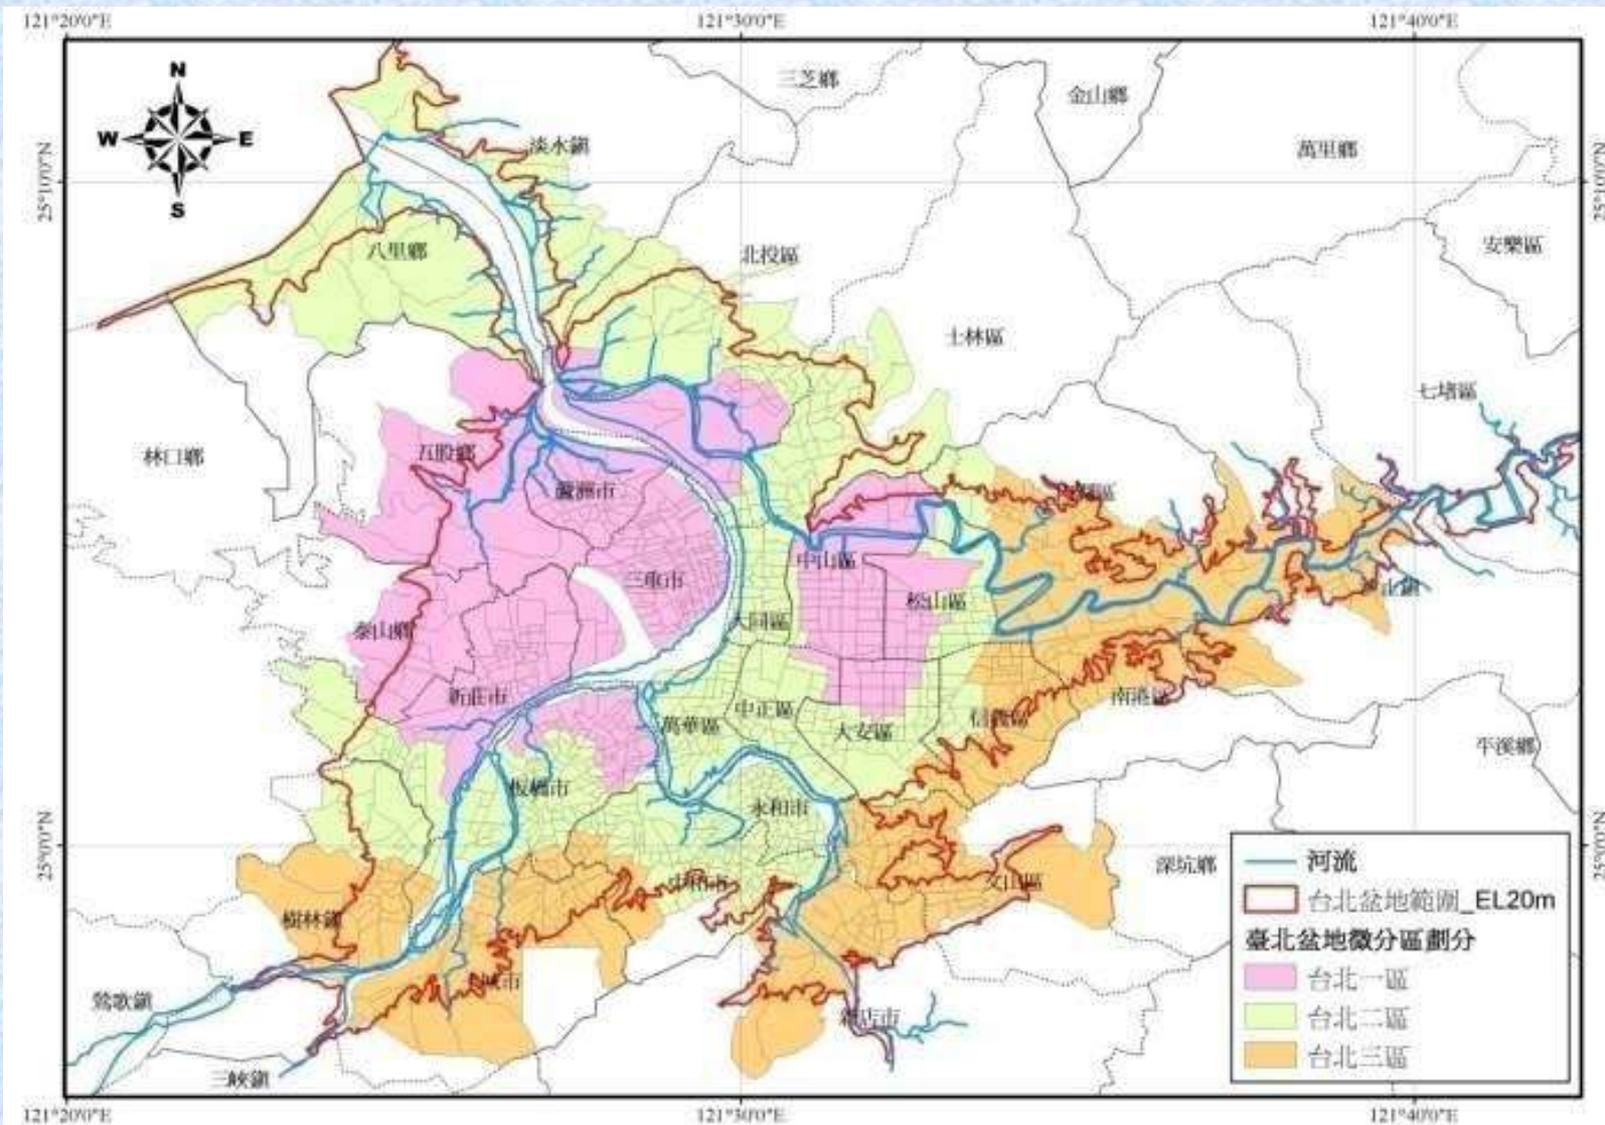
2011.1修訂後公告之臺北盆地設計地震微分區圖

Microzonation Map of Taipei Basin in the Building Code Modified on 2011.
